**KOP-FLEX® MONITORING AND
DIAGNOSTICS SERVICES**
FOR THE METALS INDUSTRY

CASE STUDY: COLD MILL SHAFT & COUPLING KEY FAILURES

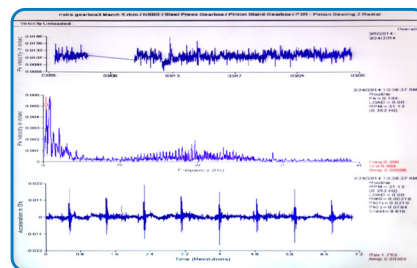
Monitoring Software

The emergence of high strength steels has reduced rolling mill drive train reliability due to the increased rolling forces required to process these new products. Reducing the peak torques and vibratory torques is one approach to prolong the life of drive train components and can be accomplished by altering the system torsional dynamics. Kop-Flex and Jaure torque monitoring services can demonstrate how to model the dynamic torsional response, normalize the model with empirical data, and evaluate the effectiveness of increased damping and stiffness changes. These analyses have led to the successful implementation of design changes at several mills, increasing drive train reliability and providing means to establish more precise maintenance intervals.
